04 Dec 2023

Bundaberg Regional Council
PO Box 3130
BUNDABERG QLD 4670

Project Name: Building Appraisal – Bathing Huts | Meadowvale
Project No: 23E-0526

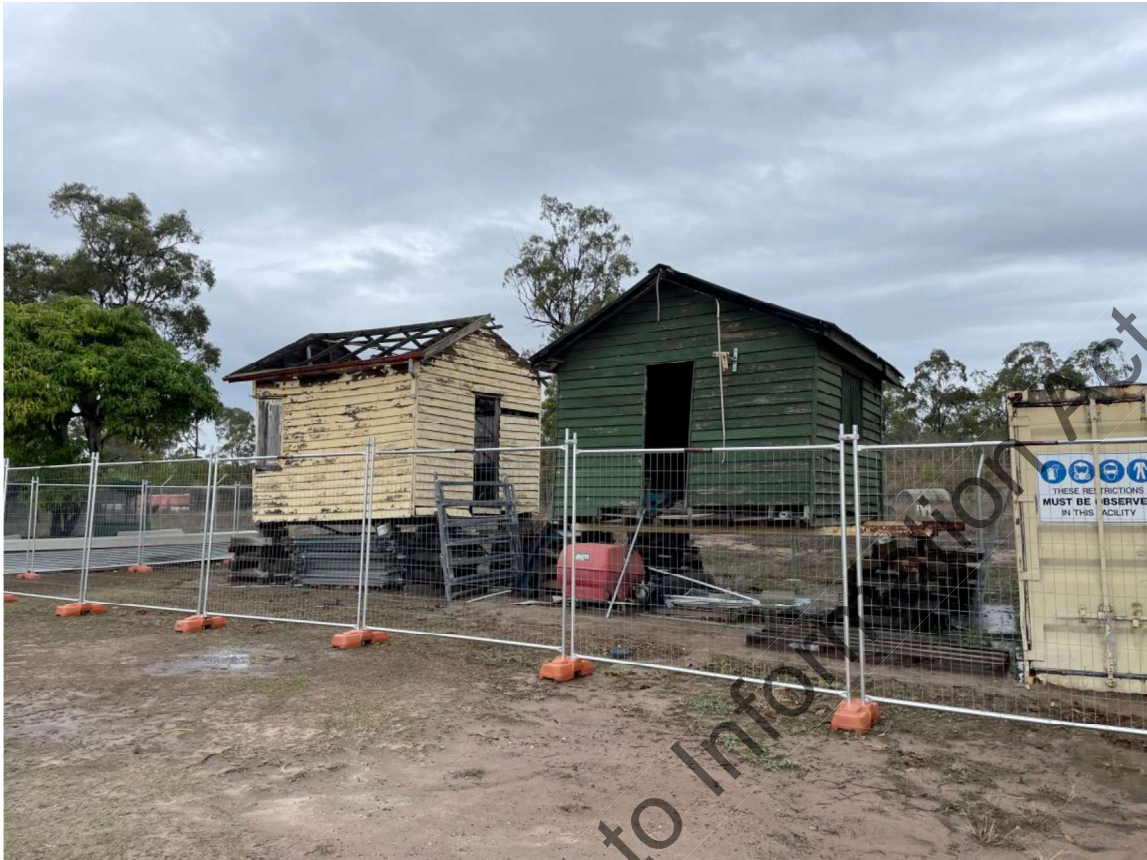
There are two huts, which we have typically referred to as the "green" and "cream" hut in this letter.

Figure 1 – Existing huts in storage at depot.

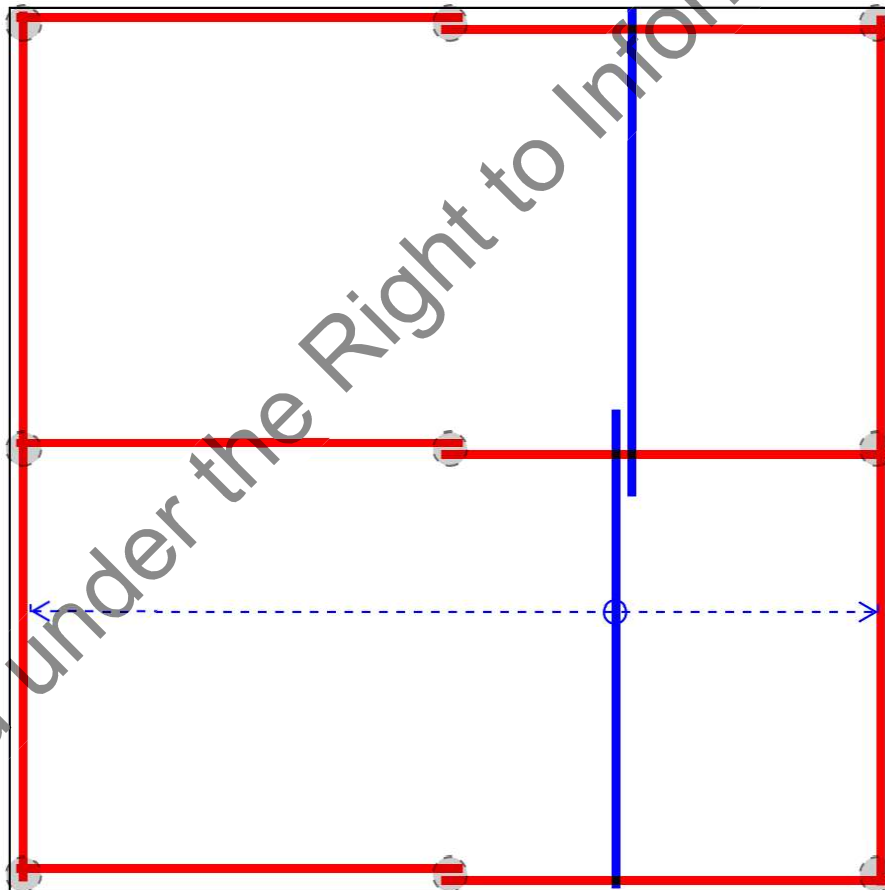
- Red lines. Denotes 70x90 timber bearer.
- Blue lines. Denotes 50x90 timber joists at approx. 500crs.
- Gray circles. Denotes assumed locations of the original stumps.

Figure 2 – Indicative timber floor frame

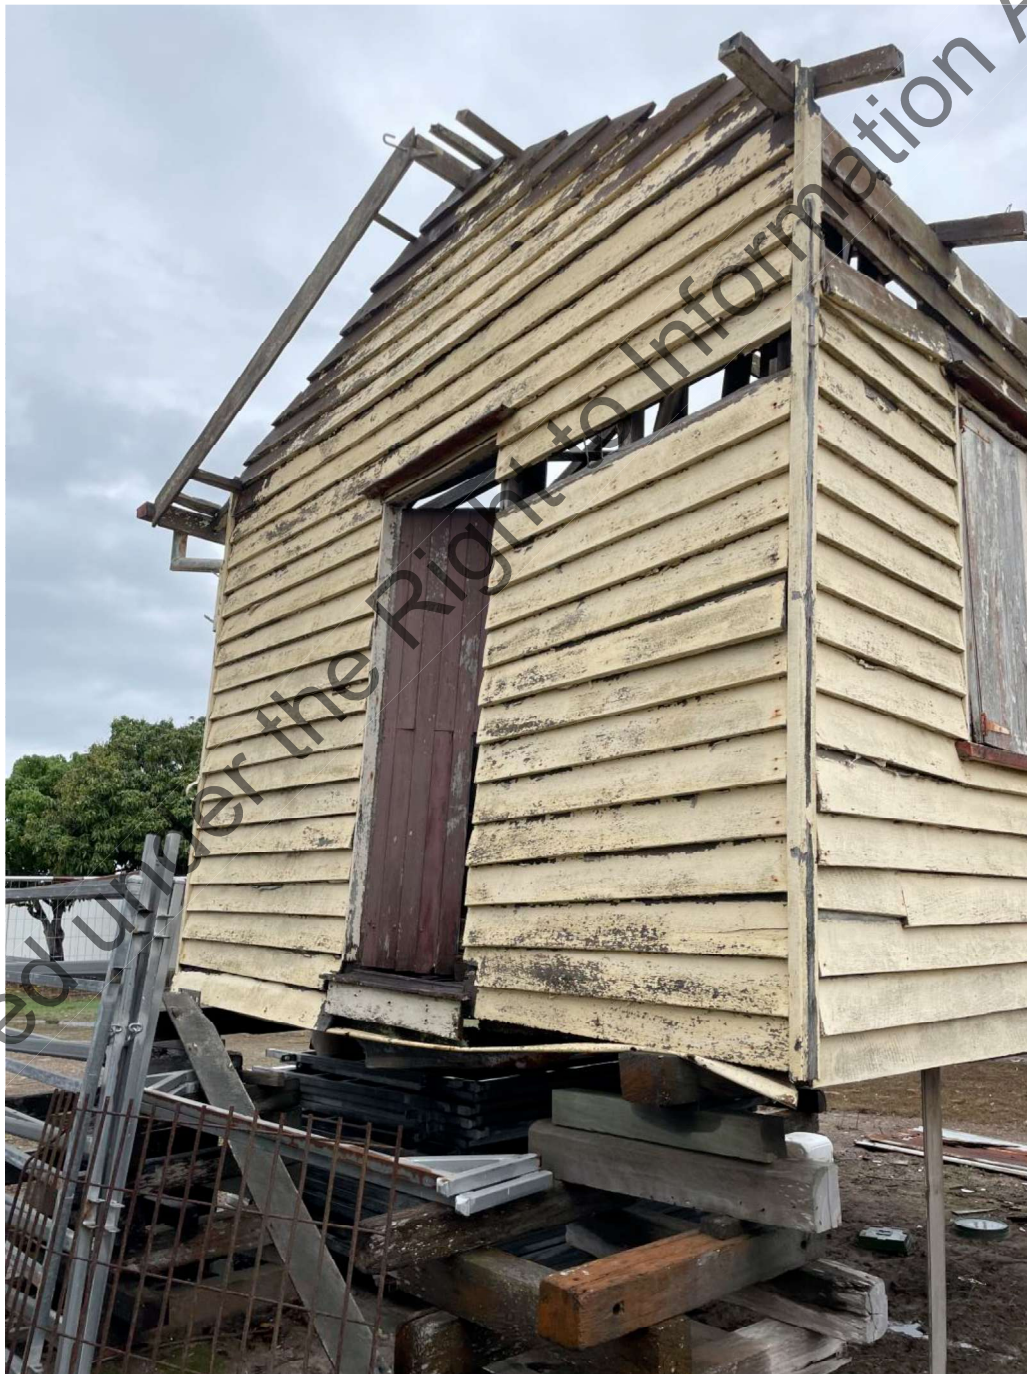
- The walls were generally significantly 'out of level'.
- General framing 'out of square'.
- Significant distortion or curvature of walls in any dimension. Refer to figure 7.
- Many structural members such as bearers were significantly deflected or distorted out of shape. Refer to figure 8.

Figure 7 – Existing wall frame distorted.

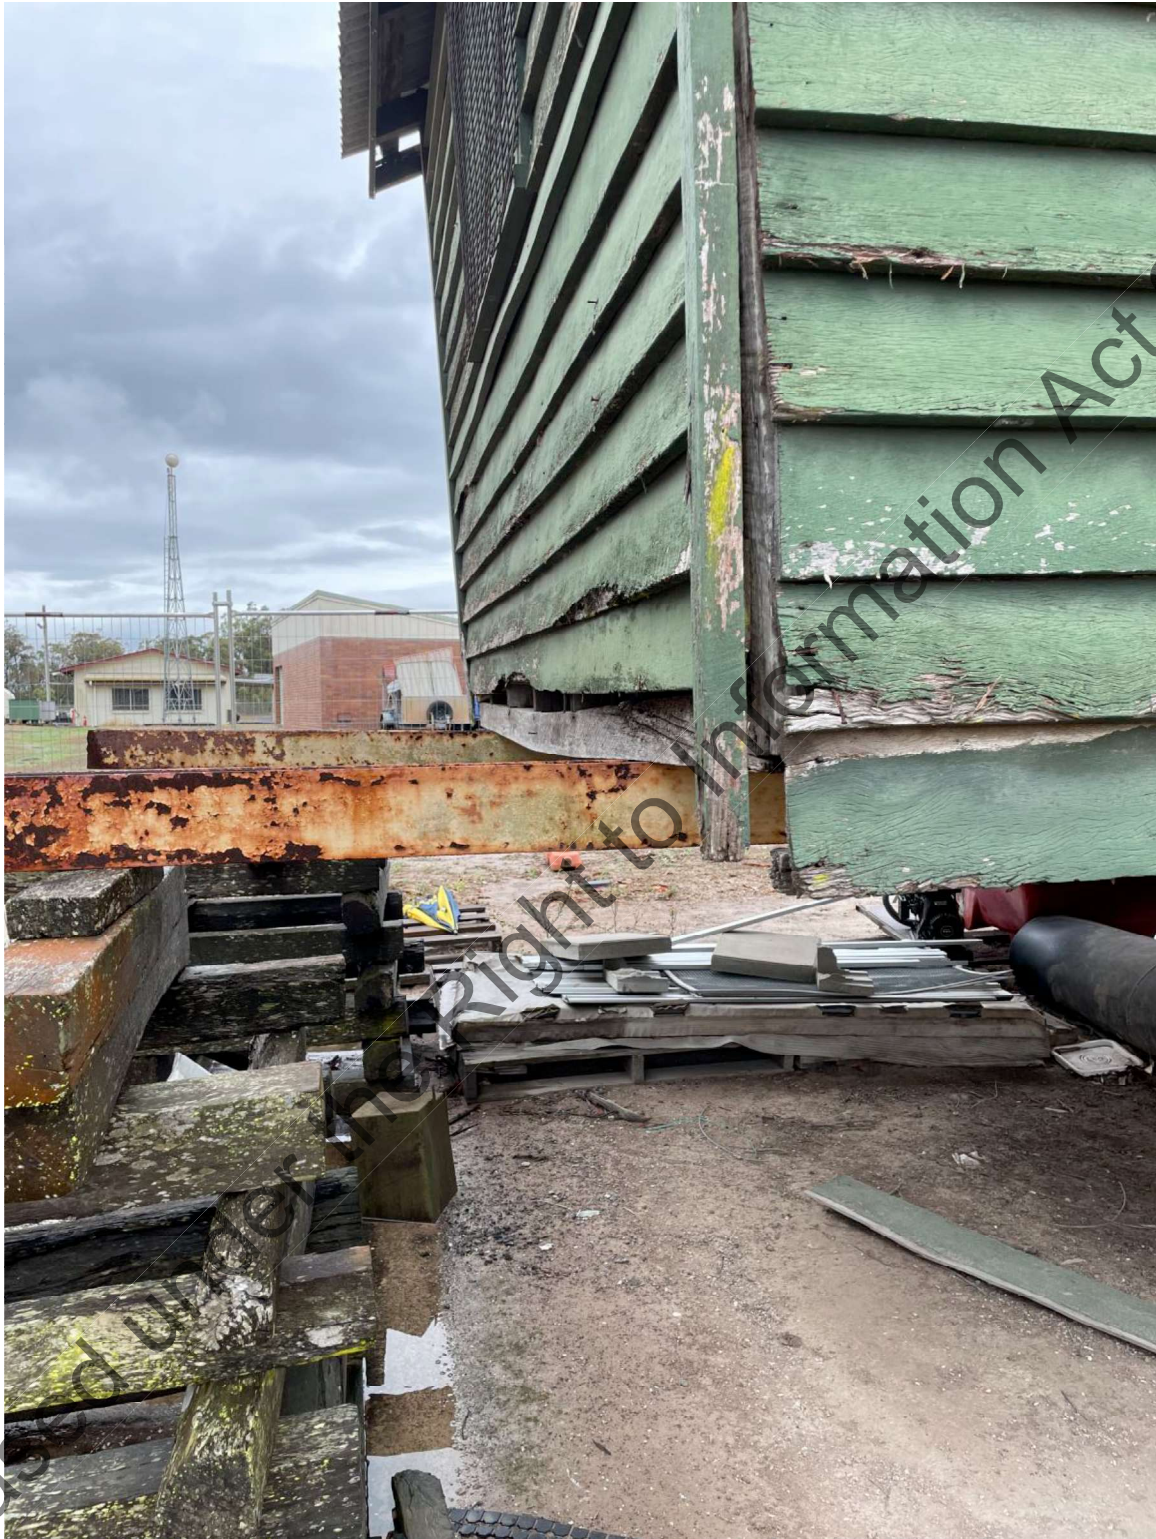
Figure 8 – Existing bearer distorted.

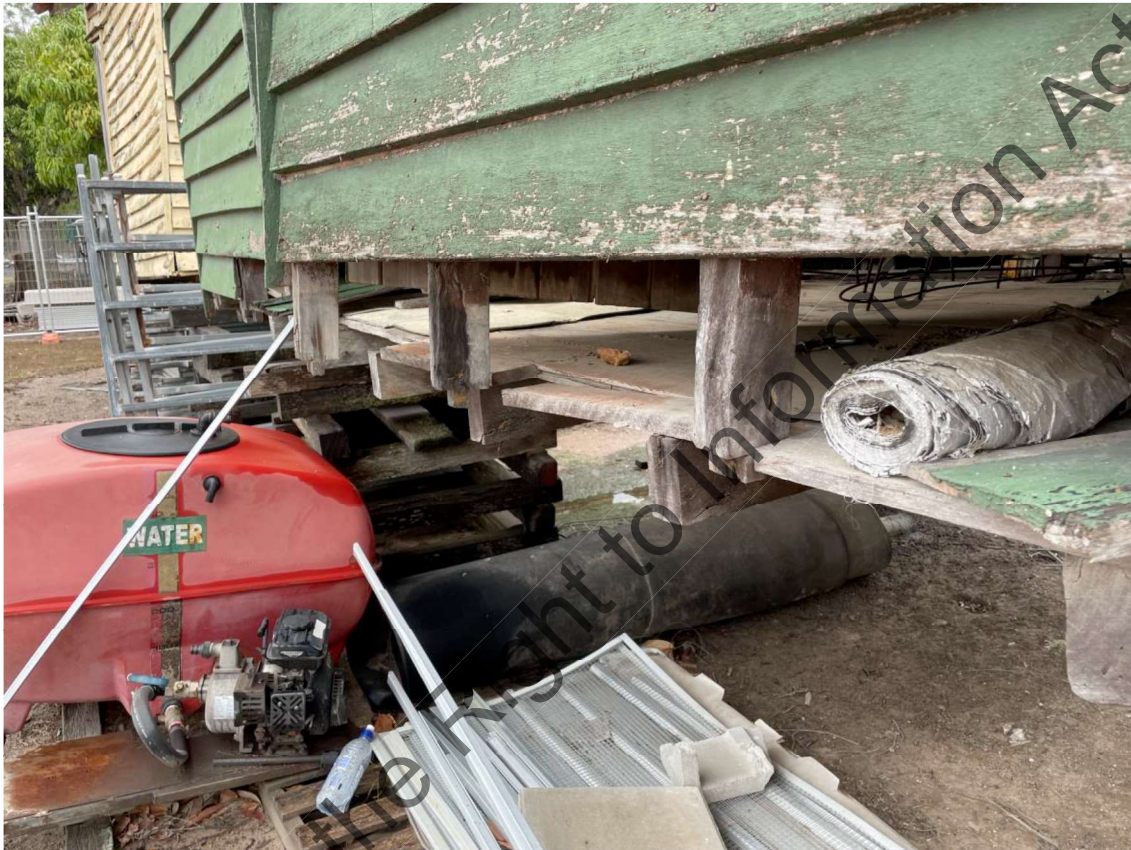
An example is a missing bearer as denoted in Figure 9, which has caused further local distortion of the floor and wall frame.

In our view missing structural members such as bearers make any potential relocation highly problematic.

Figure 9 – Existing bearer missing.

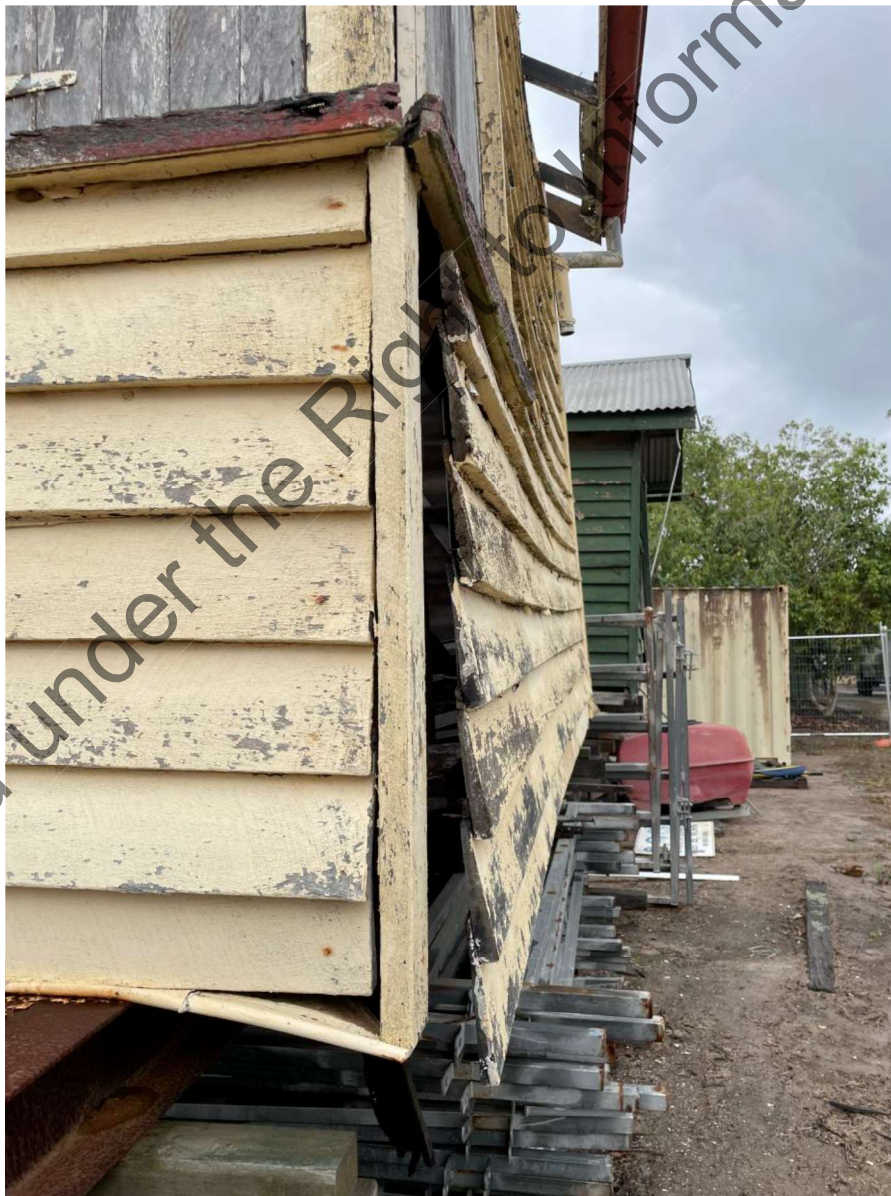
Numerous nail fixings were observed to have deteriorated. This was apparent across practically all building elements. There are numerous locations where failure of fixings has caused general framing, cladding and the like to simply fall apart.

Figure 10 provides an example of the observed state of the fixings. Nails had corroded to point where some cladding was effectively no longer attached.

- The age of the huts
- The corrosive environment they were subjected to (coastal),
- Material qualities of nails at the time of construction.

The fixings are expected to be in very poor condition. We would expect that all fixings would need to be replaced.

Figure 10 – Example of failure of fixings

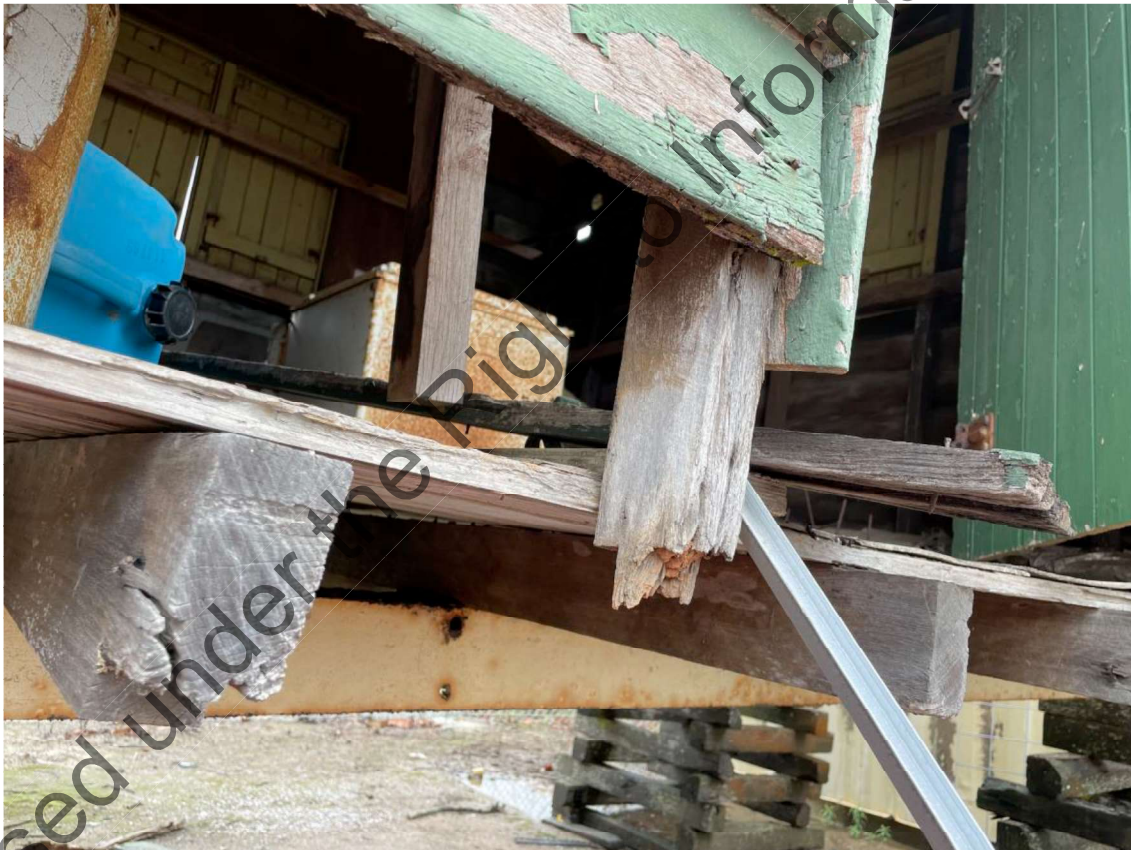
Figure 11 provides an example of apparent termites at the bottom of a stud.

Figure 11 – Example of signs of termites

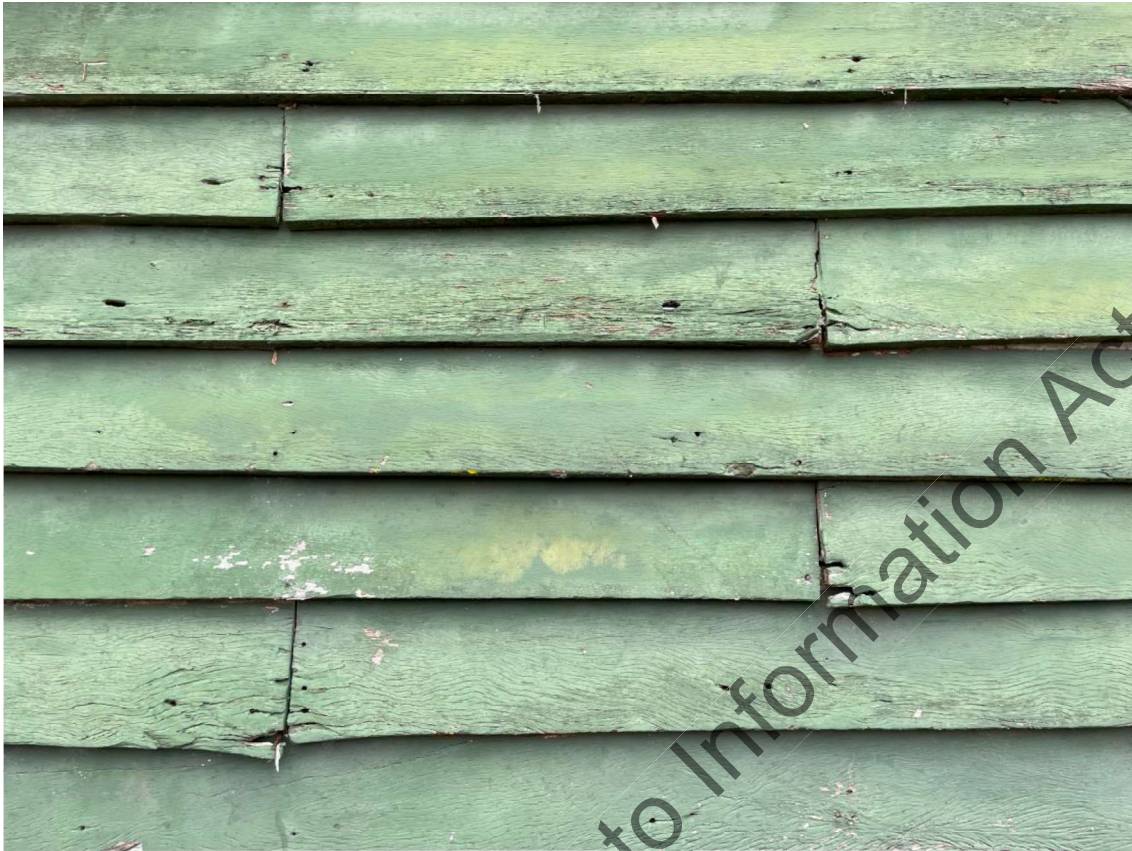
Figure 12 provides an example of the general condition of the timber weather boards, which were found to be generally ridden with dry rot.

Figure 12 – Example of dry rot in cladding.

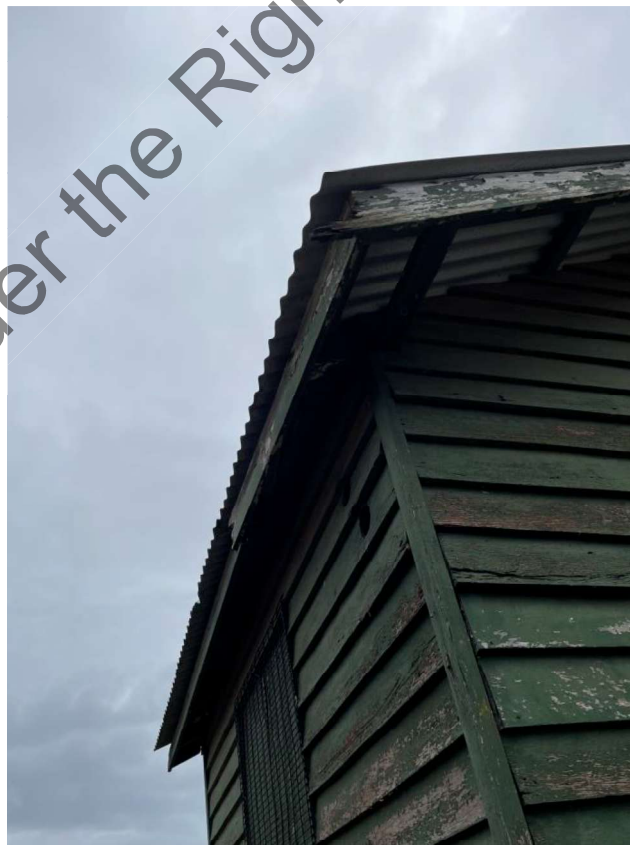
Although it could not be inspected closely, it appeared that the timber roof framing to the green hut is riddled with water damage and dry rot. This is common in old structures where roof sheets were originally nailed. The action of nailing the roof sheet would locally distort the sheet and would not fully seal in every instance. Water was prone to entering the nail fixings, causing slow decay of the timber.

Figure 13 – Example of decay in roof framing.

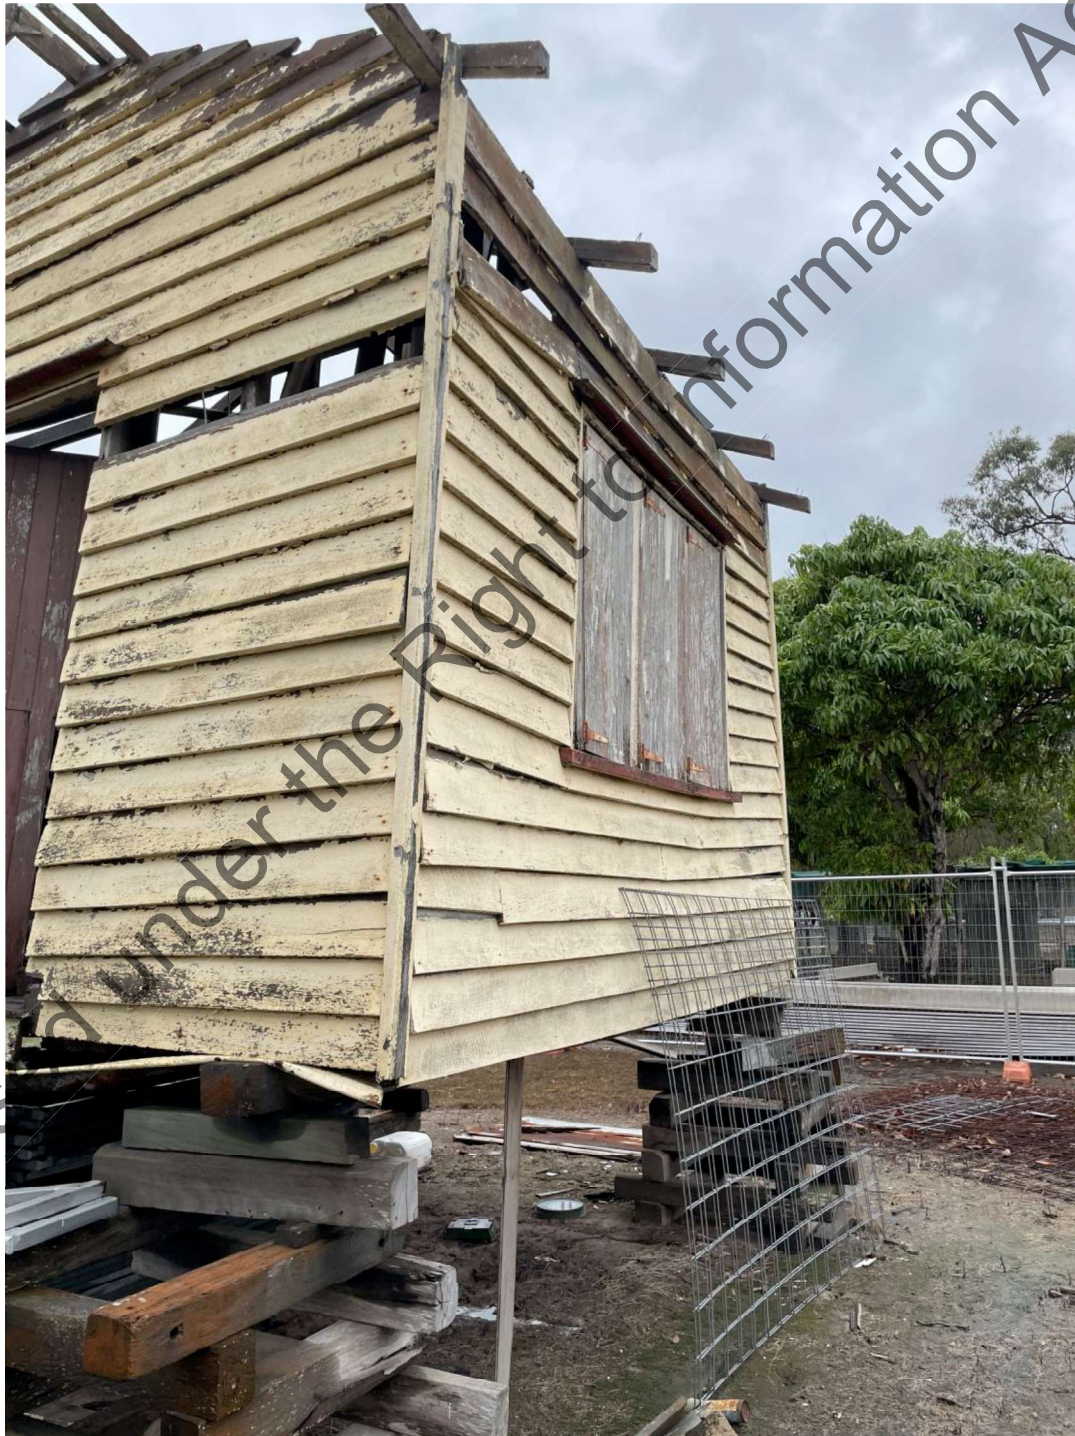
At the 'cream' hut, the roof has collapsed into the hut.

The loss of the roof has left the internal framing of the hut fully exposed to the elements. It appears this has significantly accelerated the degradation of the structure.

The roof framing is also important structurally to generally tie the structure together. The wall frames in particular would be much less stable without a secure roof structure.

Figure 14 – Collapsed roof framing

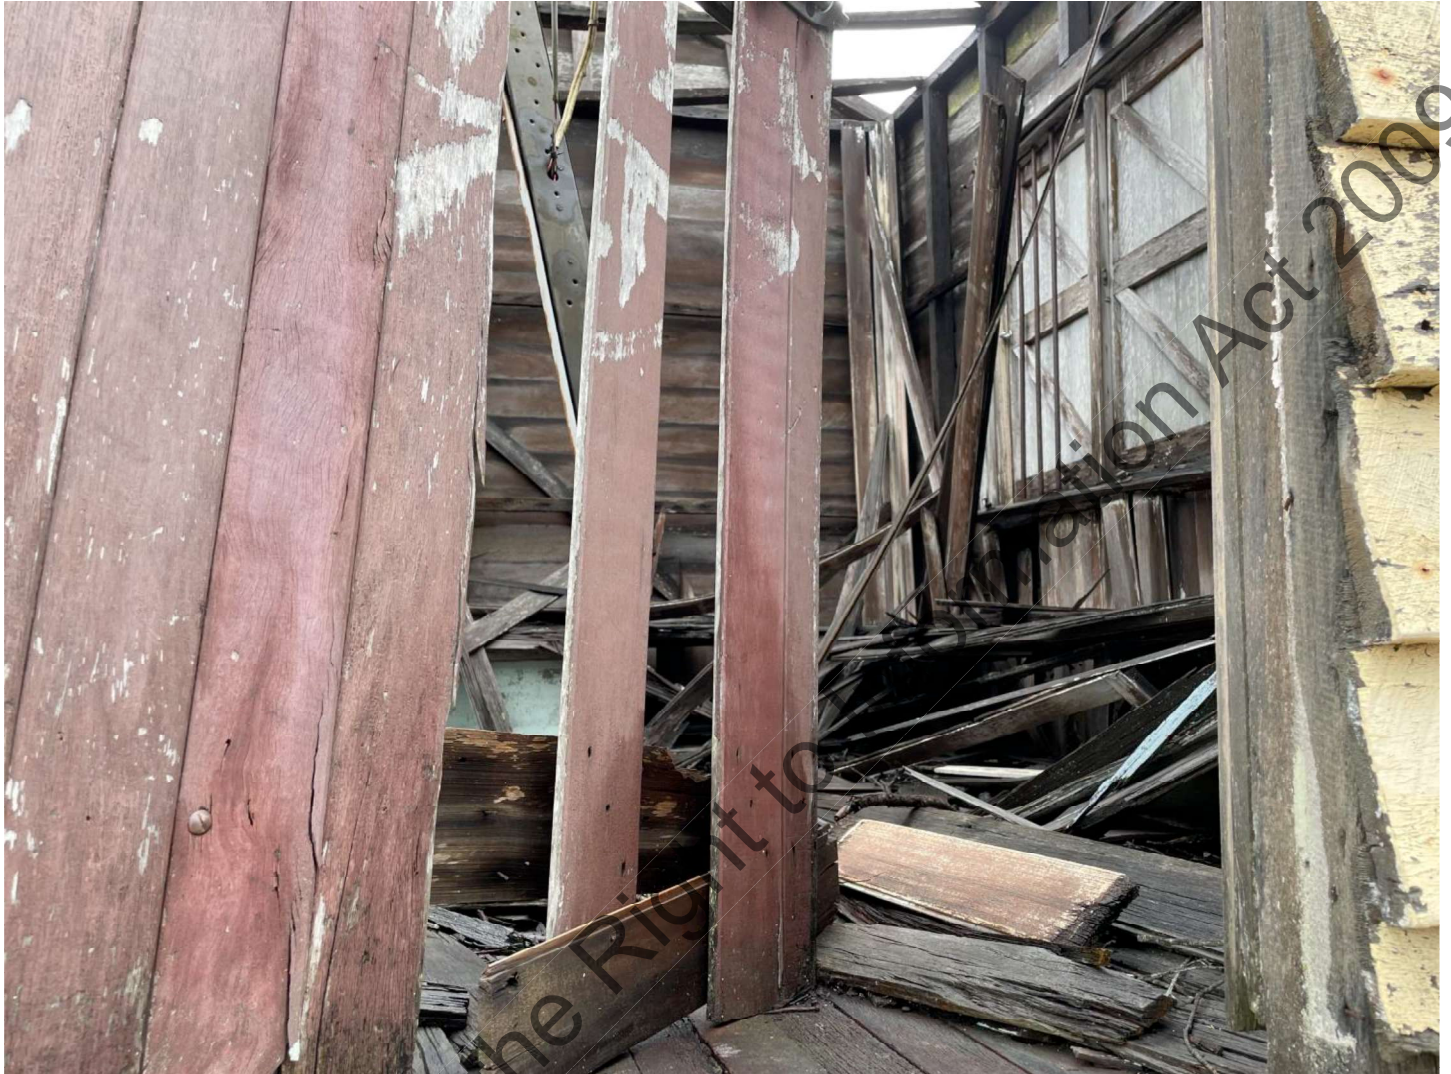
Figure 14 – Collapsed roof framing inside the hut

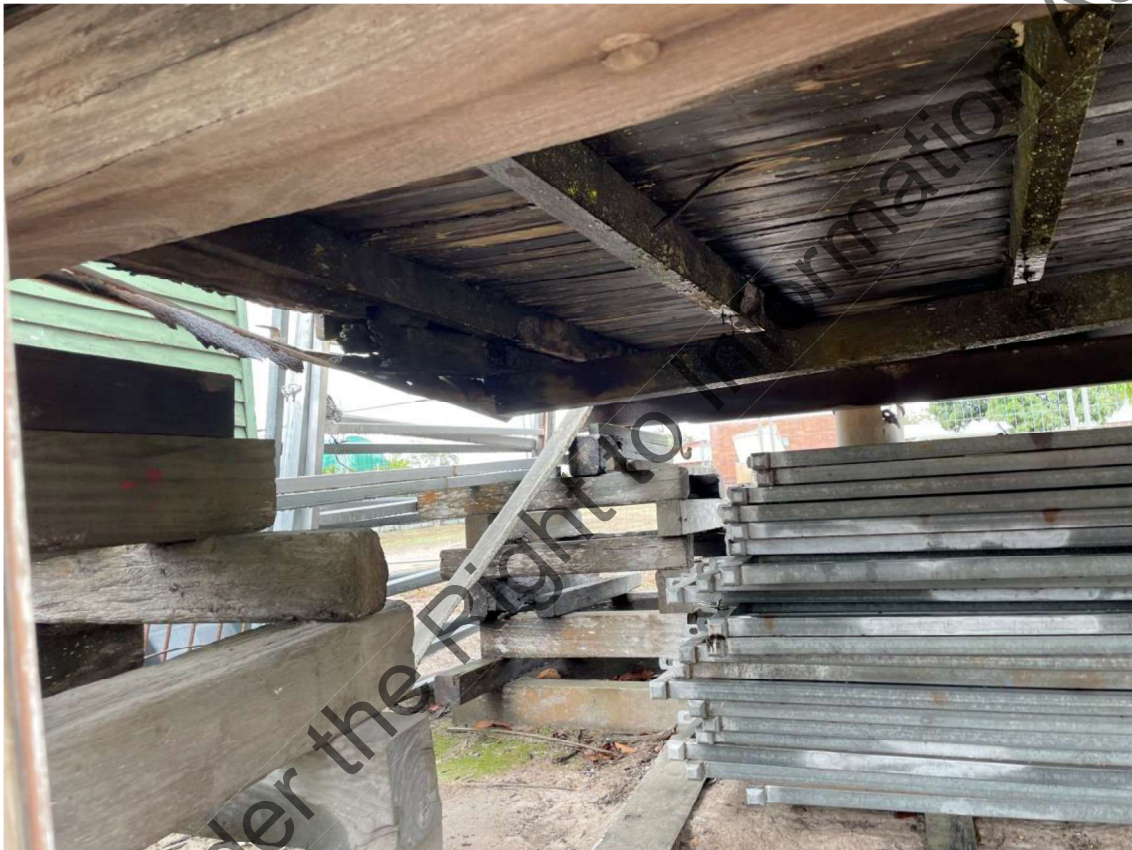
Figure 15 provides an example of some floor collapse, where an edge bearer has deteriorated to the point of failure.

In our opinion, based on the visible condition of the timber floor framing the huts may be at risk of sudden collapse.

Figure 15 – Partial collapse to floor framing.
