East Water Tower

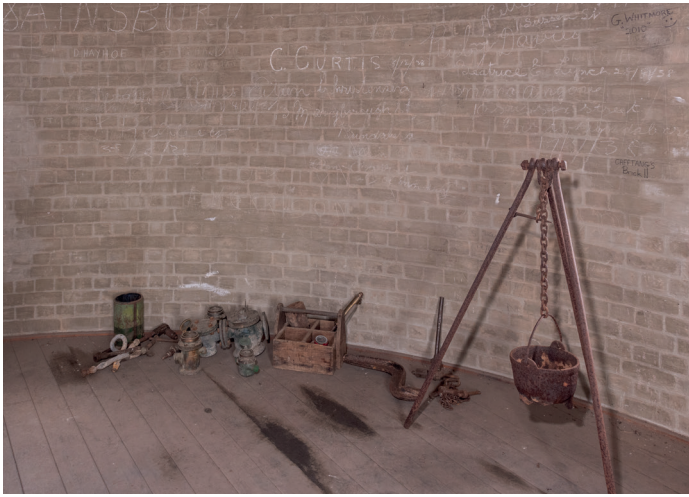
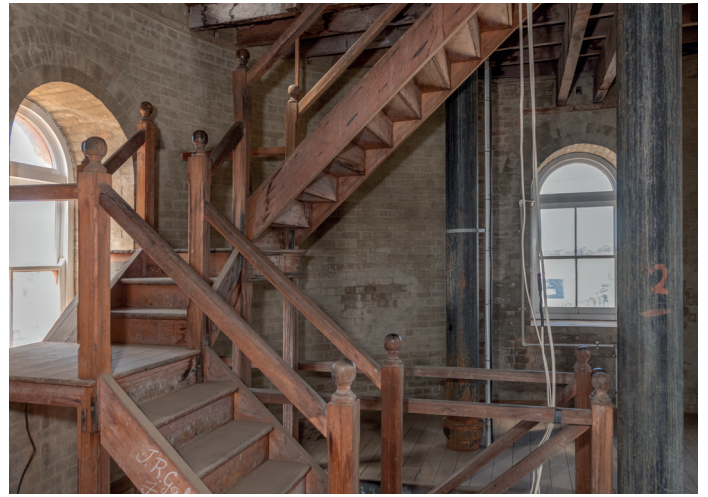
- Constructed by Bundaberg builder N.C. Steffensen, the tower has eight storeys which are marked externally by a band of projecting bricks.
- The tower is constructed of red-brown glazed "Virginia" bricks set on concrete footings.
- The tower has an external diameter of 8.76 metres and a height of 32.15 metres. The walls step internally at six points from 915 mm thick at the bottom to 356 mm at the top.
- The interior contains timber floors at each level, supported by timber frames and linked by timber staircases.
- The water tower comprises a 40,000-gallon mild steel tank, constructed by the Bundaberg Foundry Company.

- The timber framed, steel sheeted roof was added to the tank in the 1970s to inhibit algae growth.
- Galvanised sheeting was added to the ground floor windows and lighting was installed at this level as a solution to vandalism.
- The stairs do not follow the design as originally documented and are thought to have been erected between 1910-1920.
